Service Bulletin

Subject: Intermittent Unable to Charge from DC Fast Charge

Models: 2014-2016 Spark EV

Built Prior to VIN Breakpoint GC570155

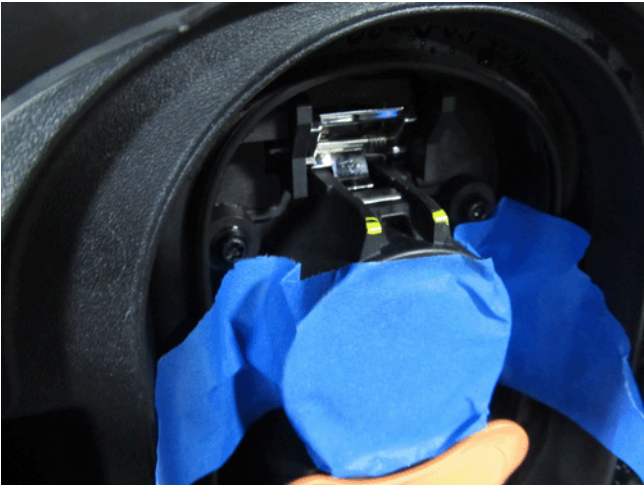
Note: Upper receptacle guides are marked in yellow for illustration purposes only.

2. Mask off the charge port so that no debris can enter the plug area, leaving exposed upper guides.
